# Peacock Hill Dam Primary Spillway Inspection Report

**March 4, 2014**

**Dam Name:** Peacock Hill Dam, VA  
Inventory # 00351

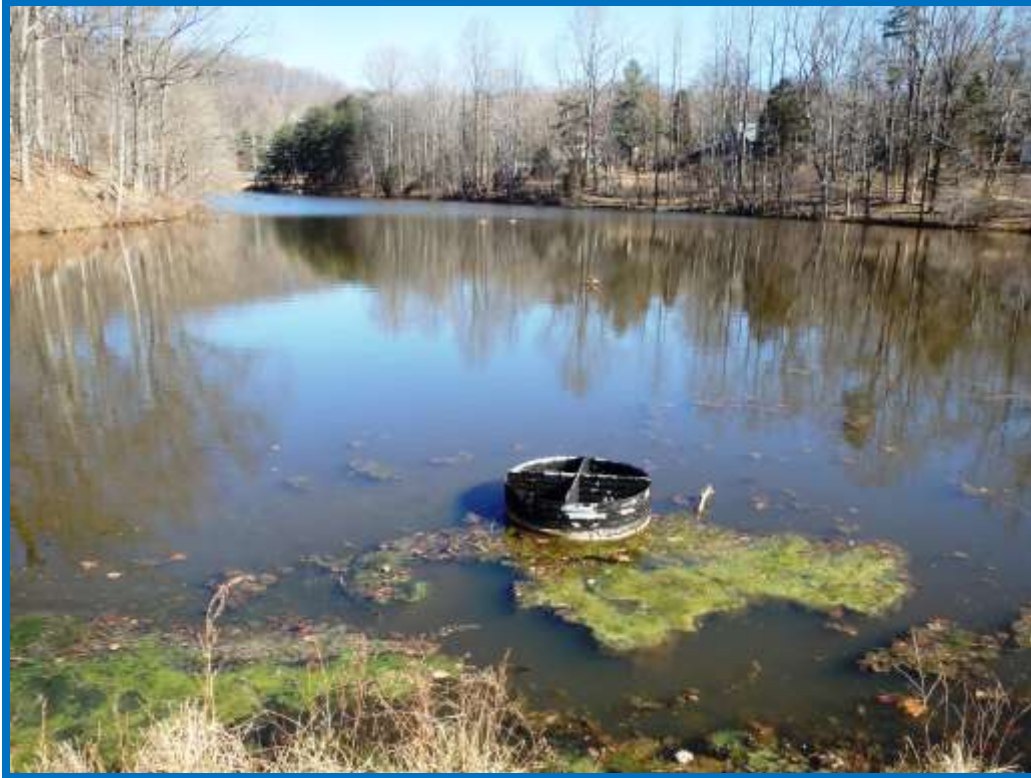
The riser intake is protected by a 48 inch CMP trash rack with anti-vortex plates. The rack is 12 inches tall and extends 2-3 inches below normal pool level. A fine metal screen is installed over the openings, and a small amount of marine debris was accumulated on the screen. The rack had some asphaltic coating remaining, was sturdily mounted and appeared to be in functional condition.

Figure 1 - Riser with Trash Rack

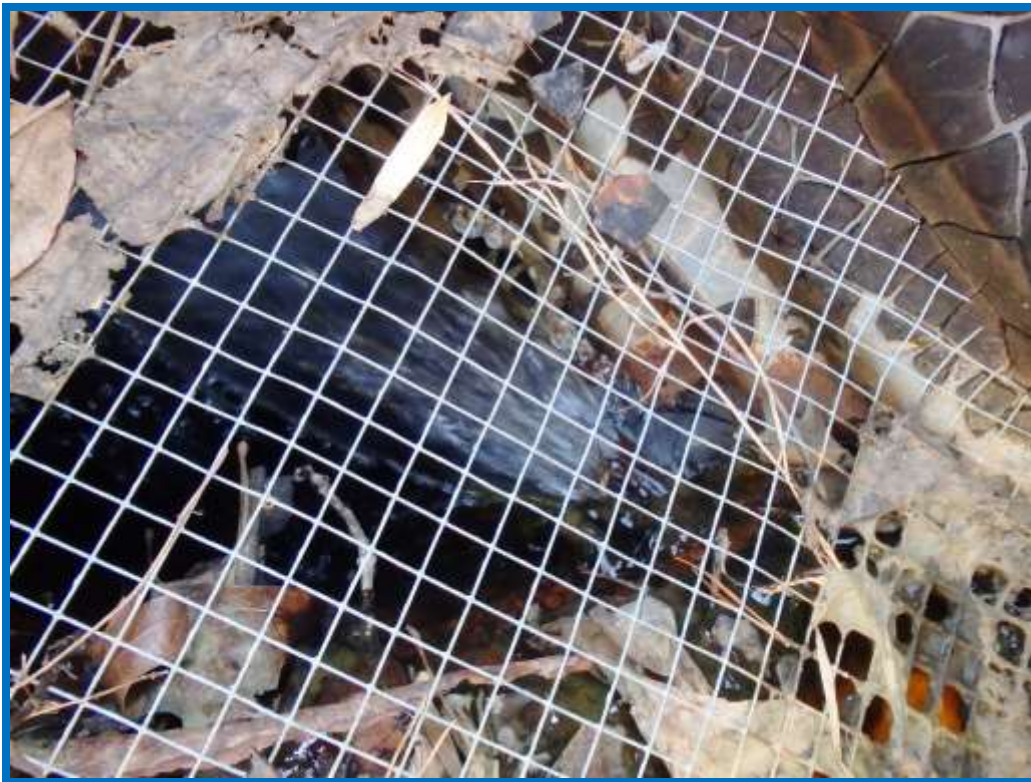
Figure 2 - Screen installed on top of trash rack

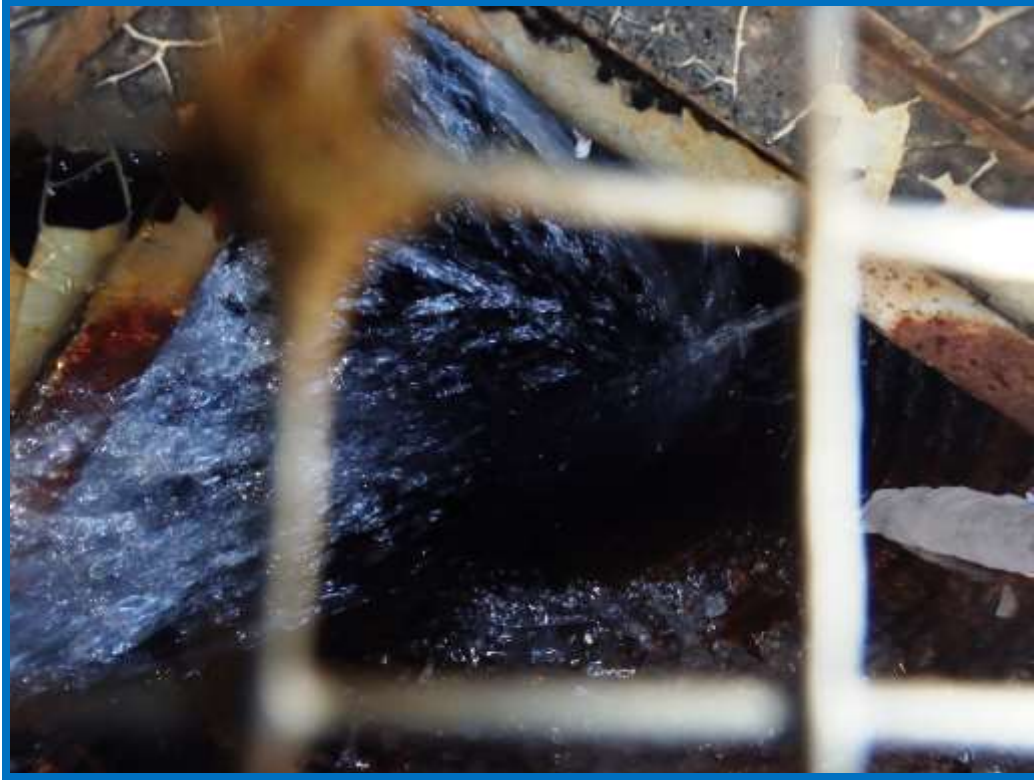
**Figure 3 - Looking down into riser before water was controlled**

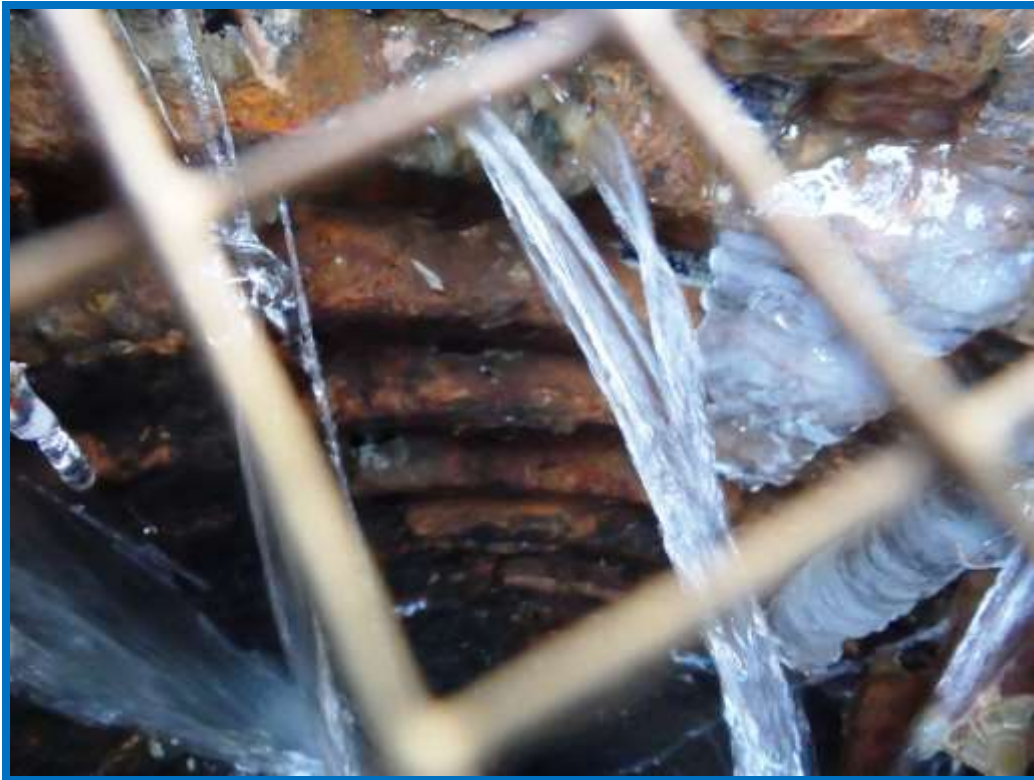
The riser pipe consists of a vertical 30 inch diameter CMP that was measured to 21 feet tall. The rim of the pipe appeared to be level, and several pinhole leaks were noted in the upper section. The connection to the horizontal outfall pipe appeared stable and no leaks were noted. Several small seeps are evident approximately half-way down the riser pipe, but no moving water was found emerging in these locations.

**Figure 4 - Picture of small pinhole leaks near top of riser**

The riser and outfall pipe are suitable for sliplining at this time. A 24 inch and 18 inch HDPE pipe could be used as a liner if an engineer found the flow characteristics to be acceptable.

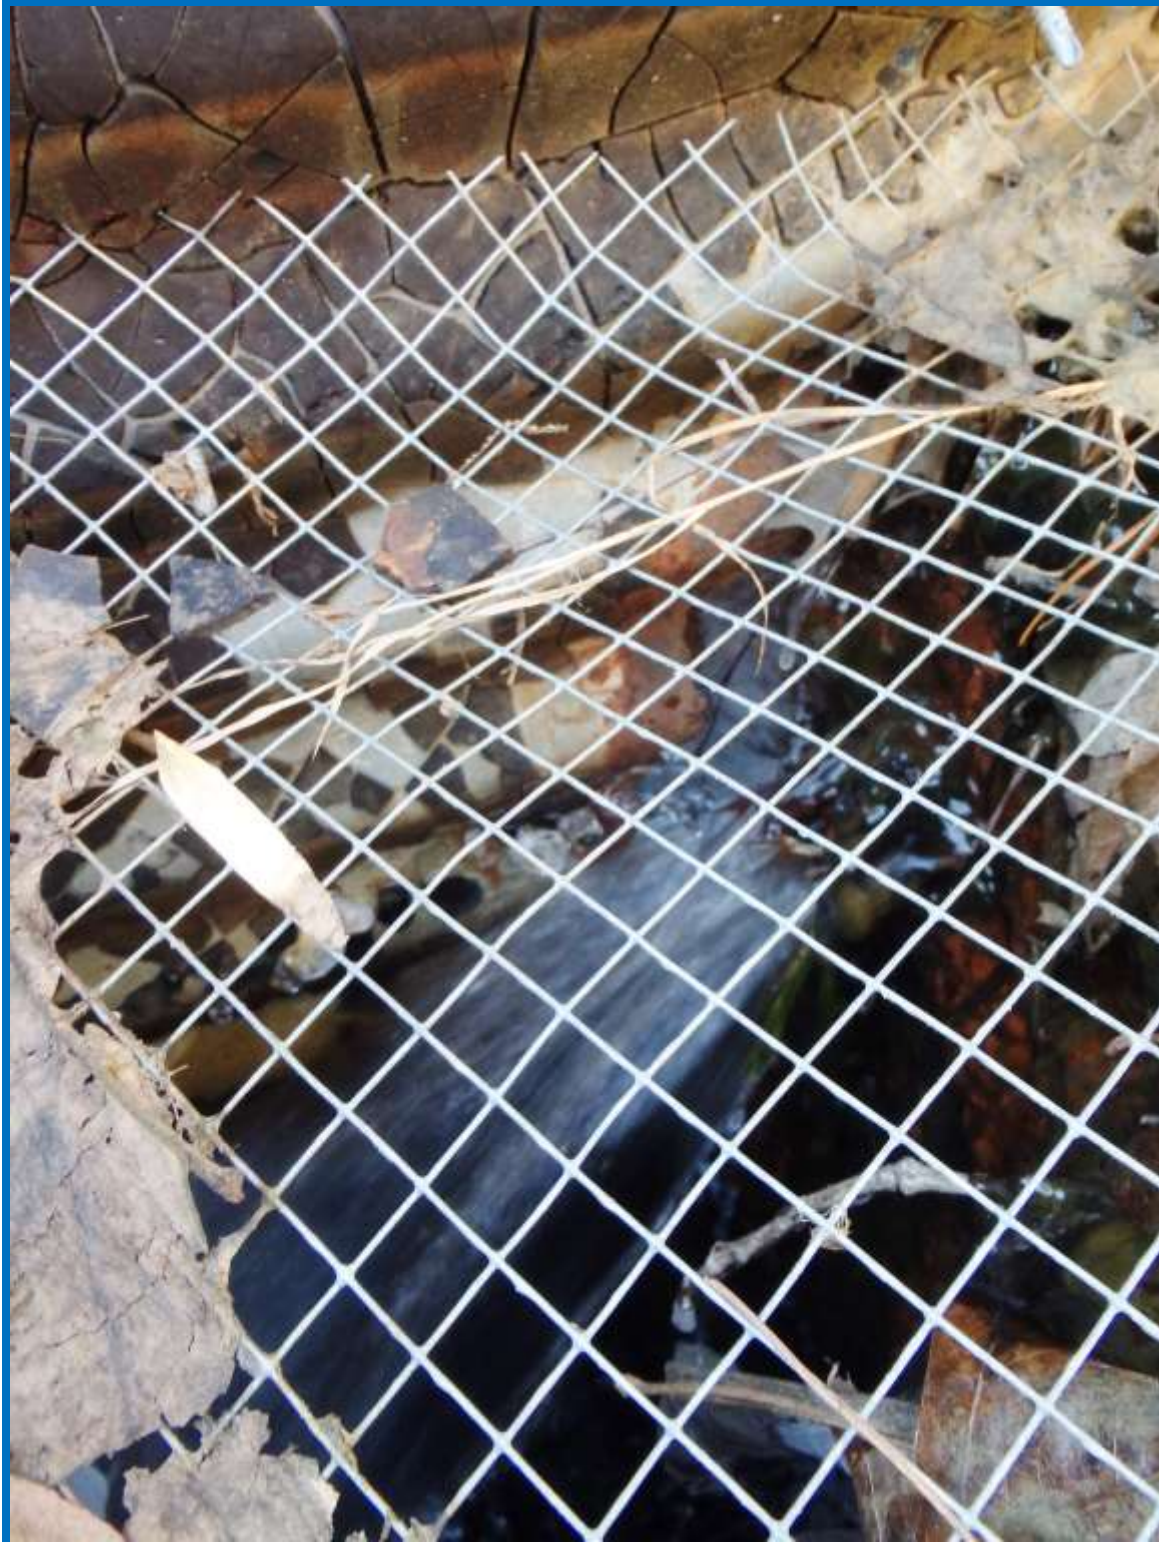
Figure 5 - Larger leak in riser

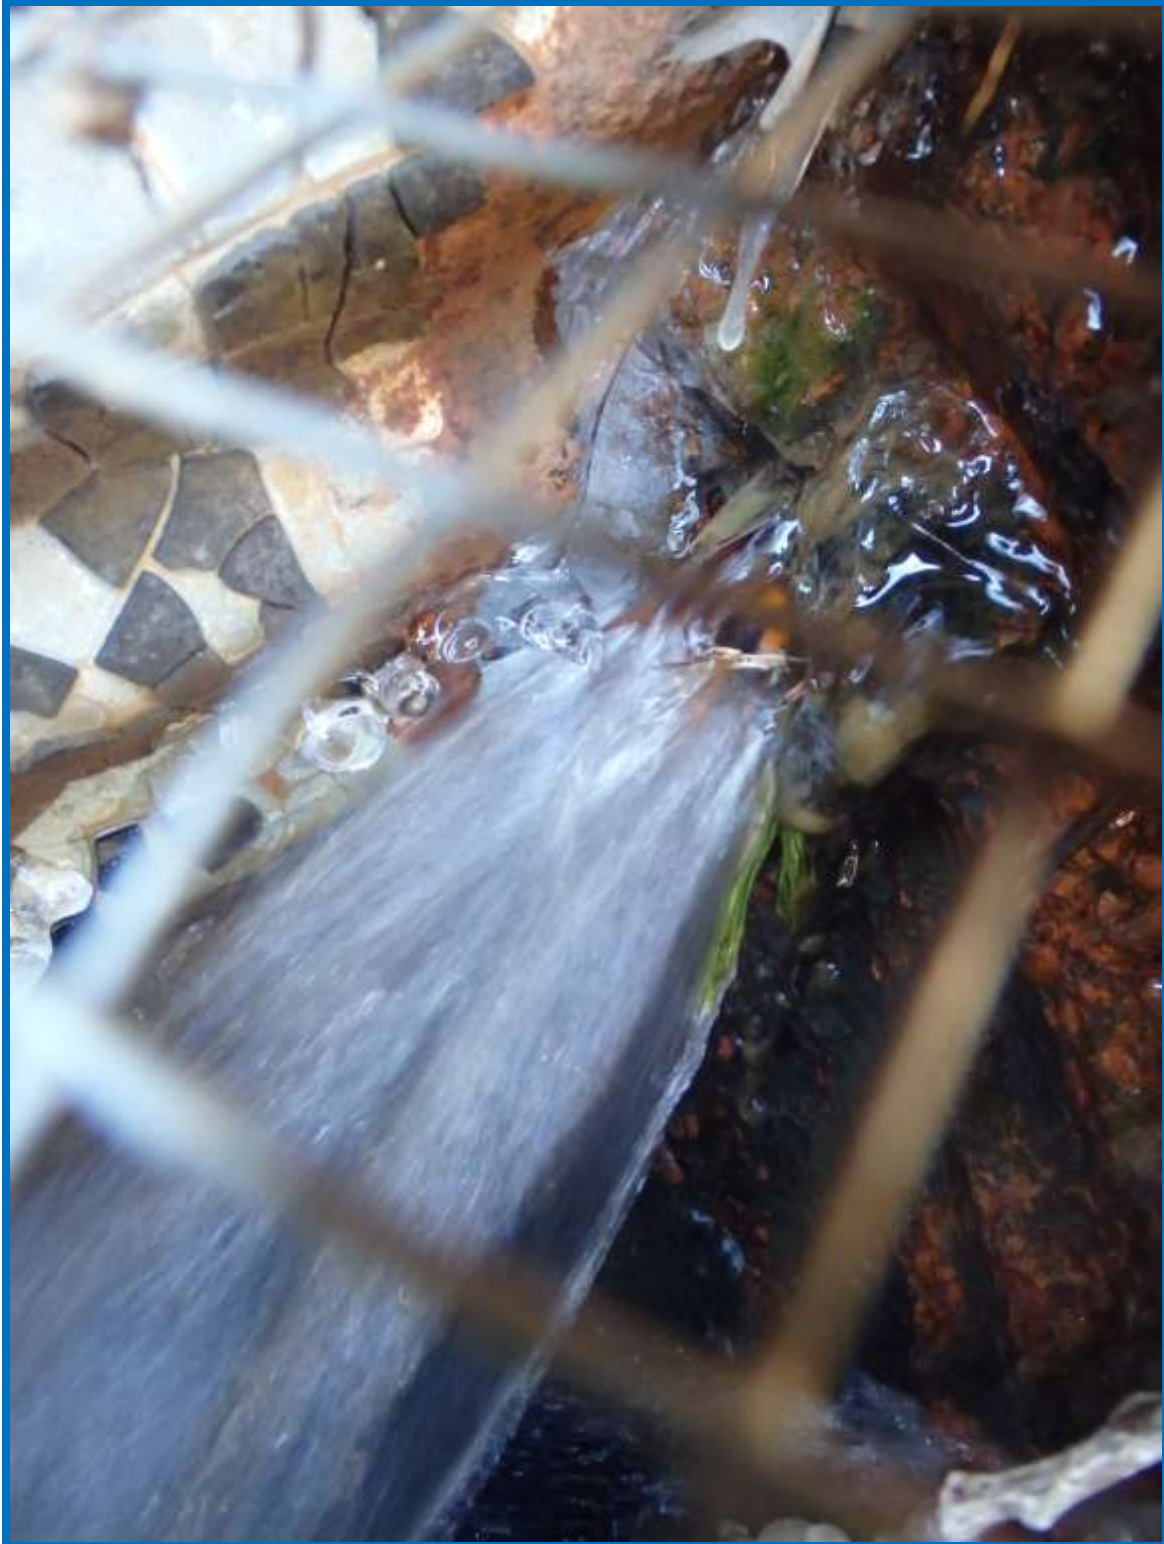
Figure 6 - Close-up on large leak in riser pipe

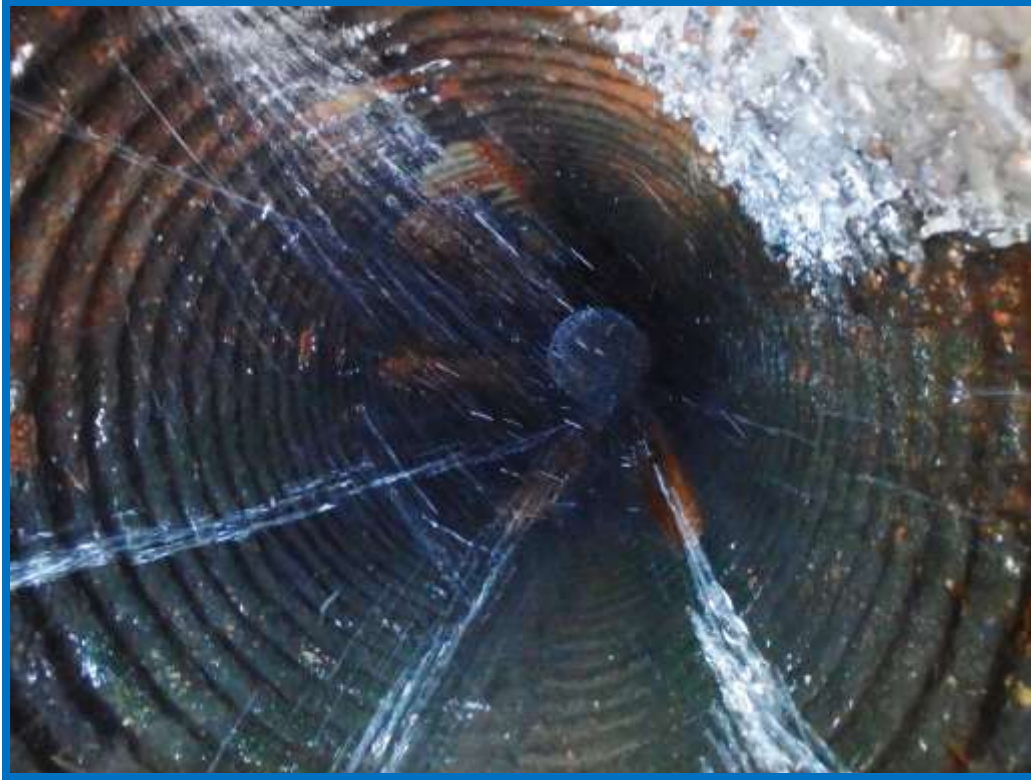
Figure 7 - Looking down into riser, note small seeps as evidence by brownish color

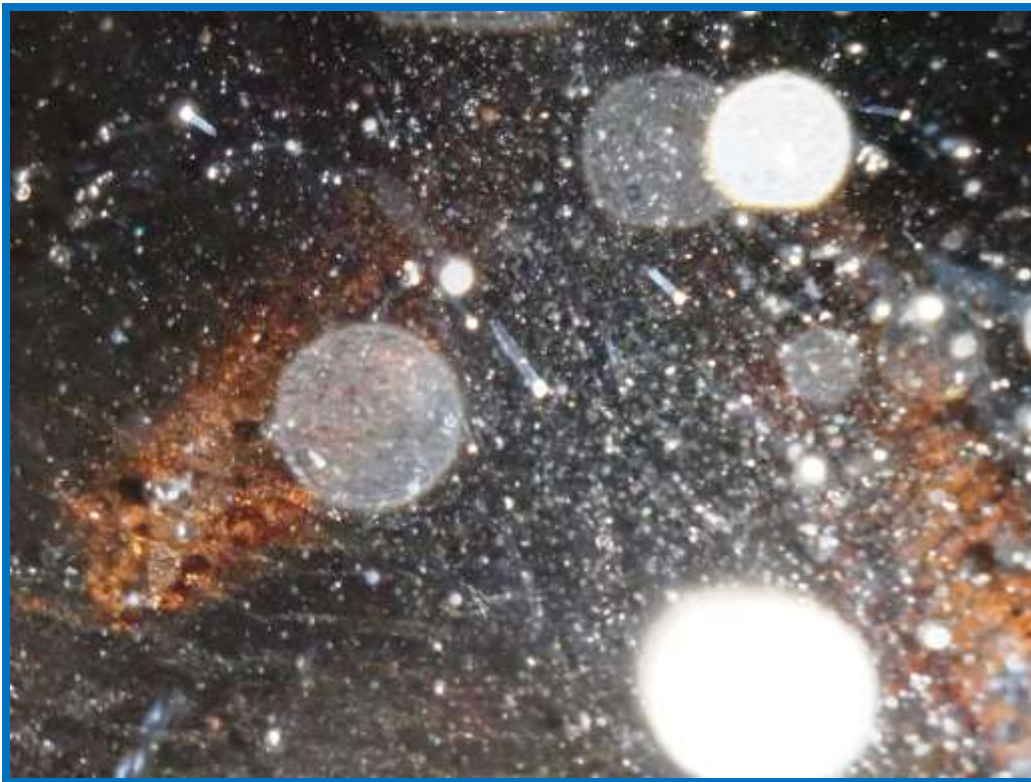
Figure 8 - Close-up of seeps in riser, approximately half-way down pipe

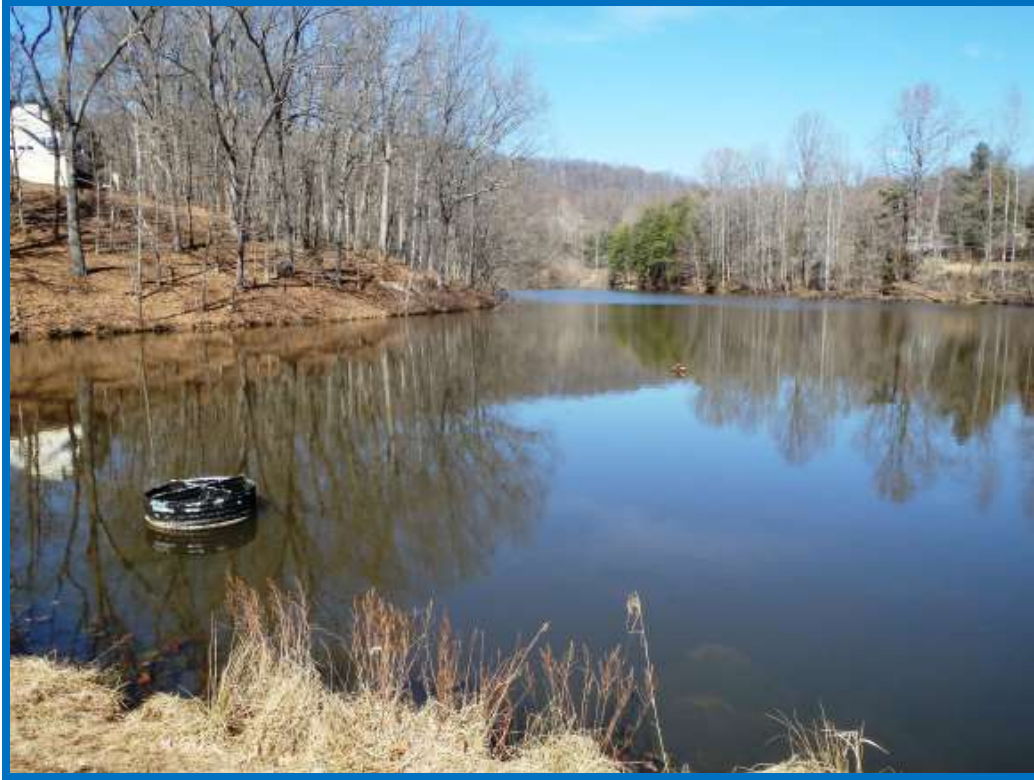
**Figure 9 - Riser and Low Level Drain Hand Wheel**

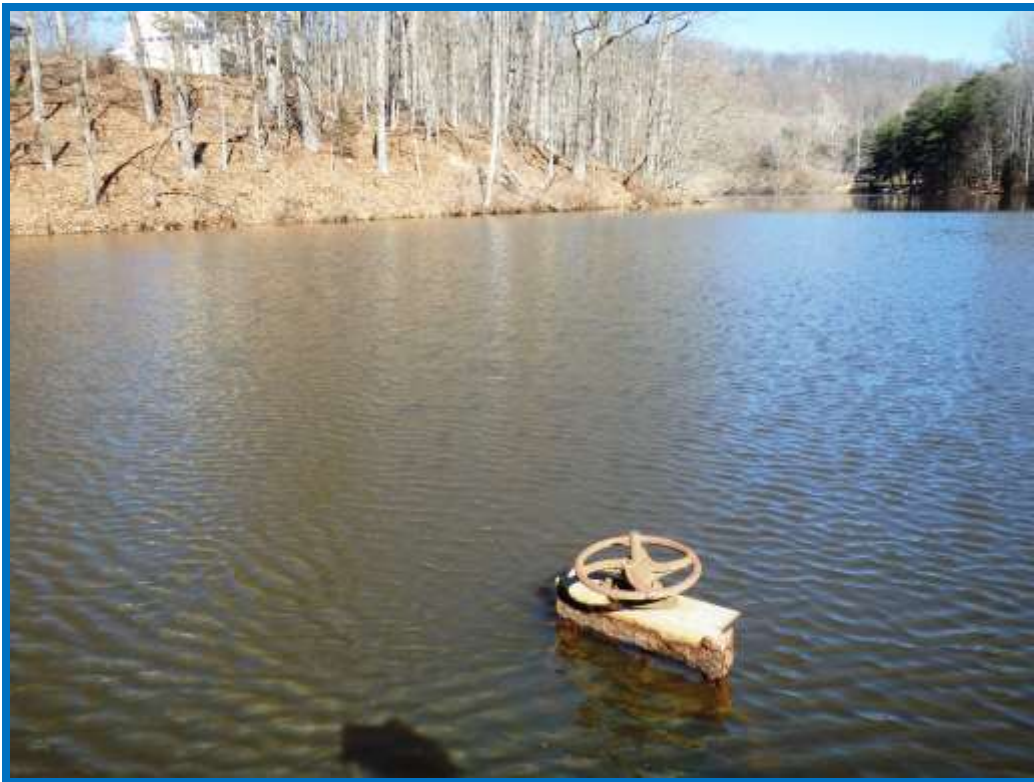
A valve hand wheel operator was visible above the lake, upstream of the riser. This pipe was not inspected directly, but onsite measurements indicate a 12 inch sluice gate, located approximately 60 feet from the riser, on the lake bottom. There was no significant flow observed to indicate leakage along this section. Sediment levels indicate this valve is not covered, but lack of recent operation would probably render this valve inoperable except with the use of divers in an extreme emergency.

**Figure 10 - Low Level Drain Hand Wheel**

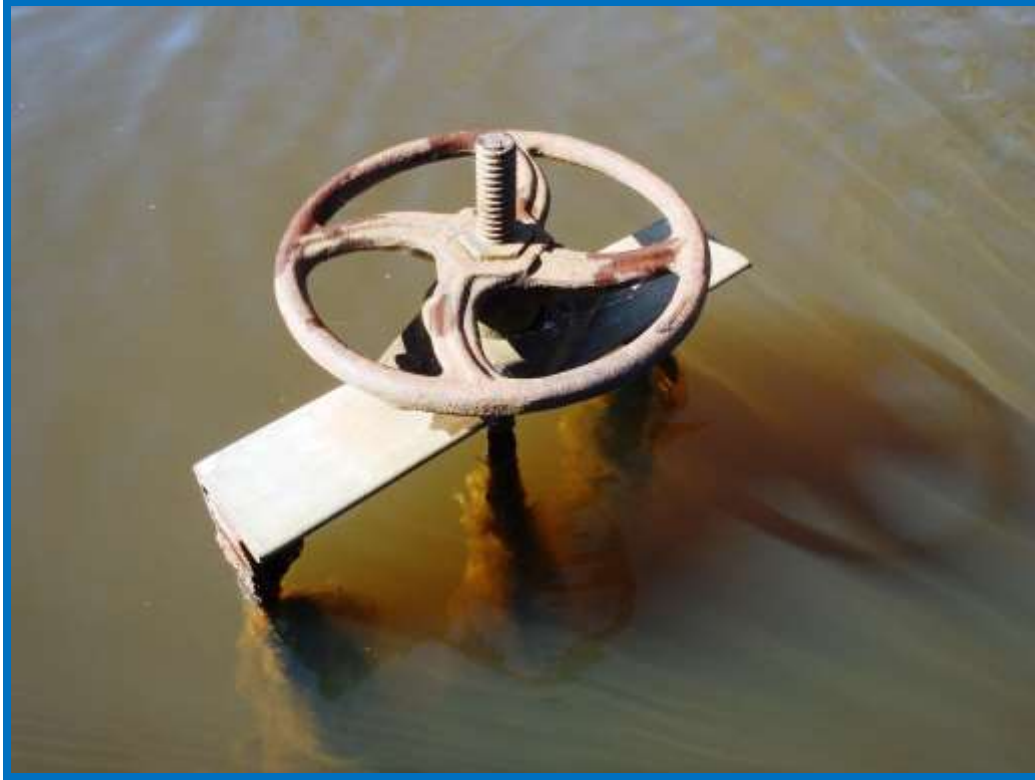
Figure 11 - Close-up of Hand Wheel

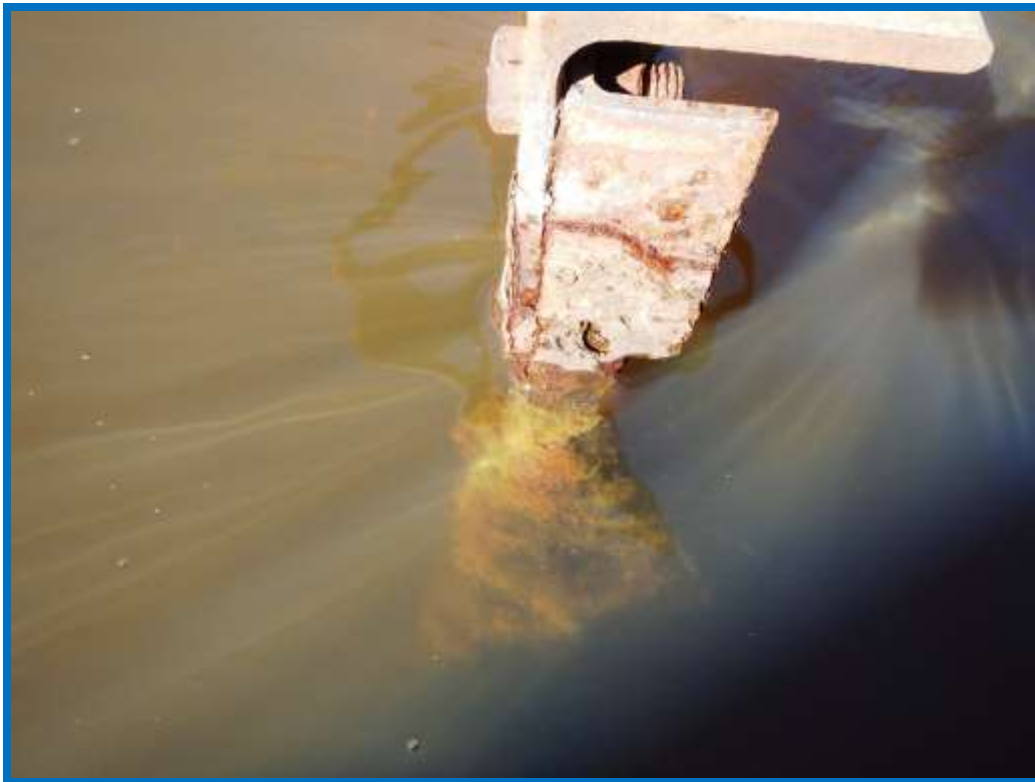
Figure 12 - Sluice Gate Frame is deteriorated

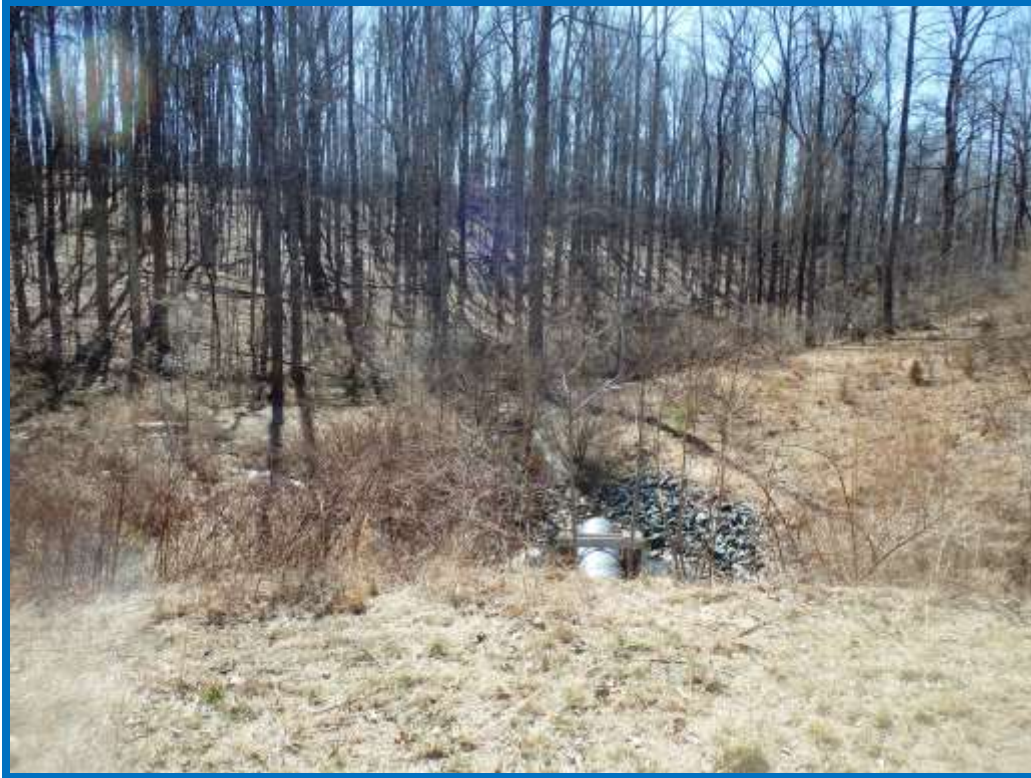
The large drop from the outfall to the plunge pool creates high energy, erosive water in this location, and it may be wise to add additional rip rap or armoring here in conjunction with other work.

**Figure 13 - Looking downstream at plunge pool and outfall pipe**

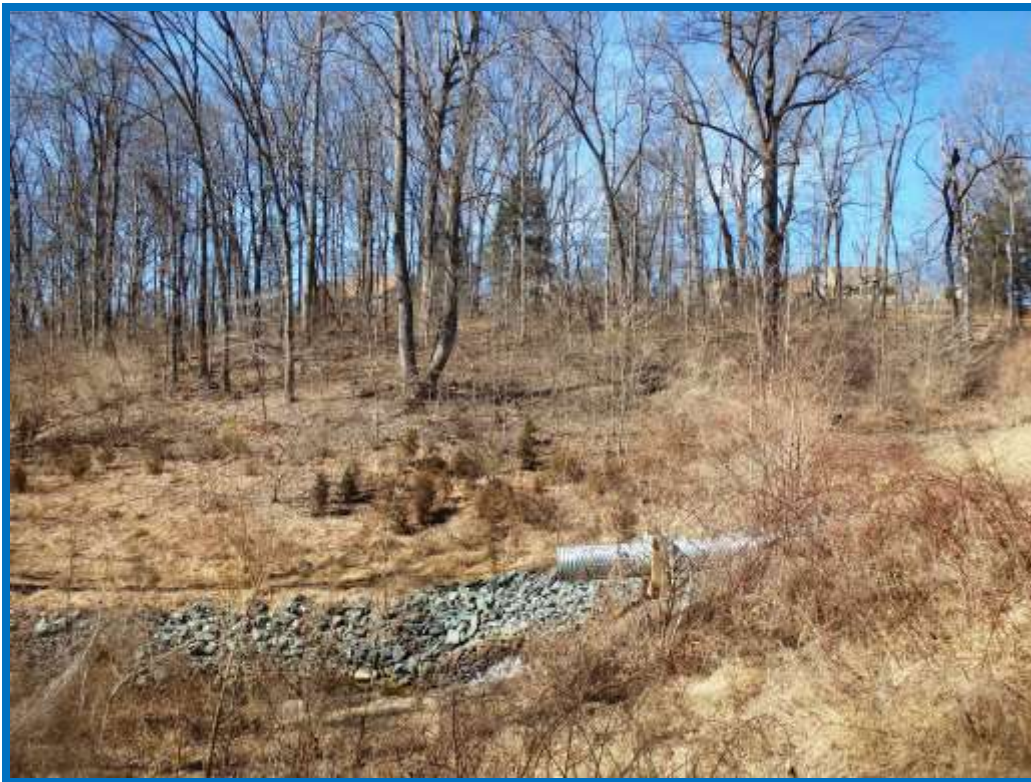
**Figure 14 - Looking towards right abutment at primary spillway outfall pipe**

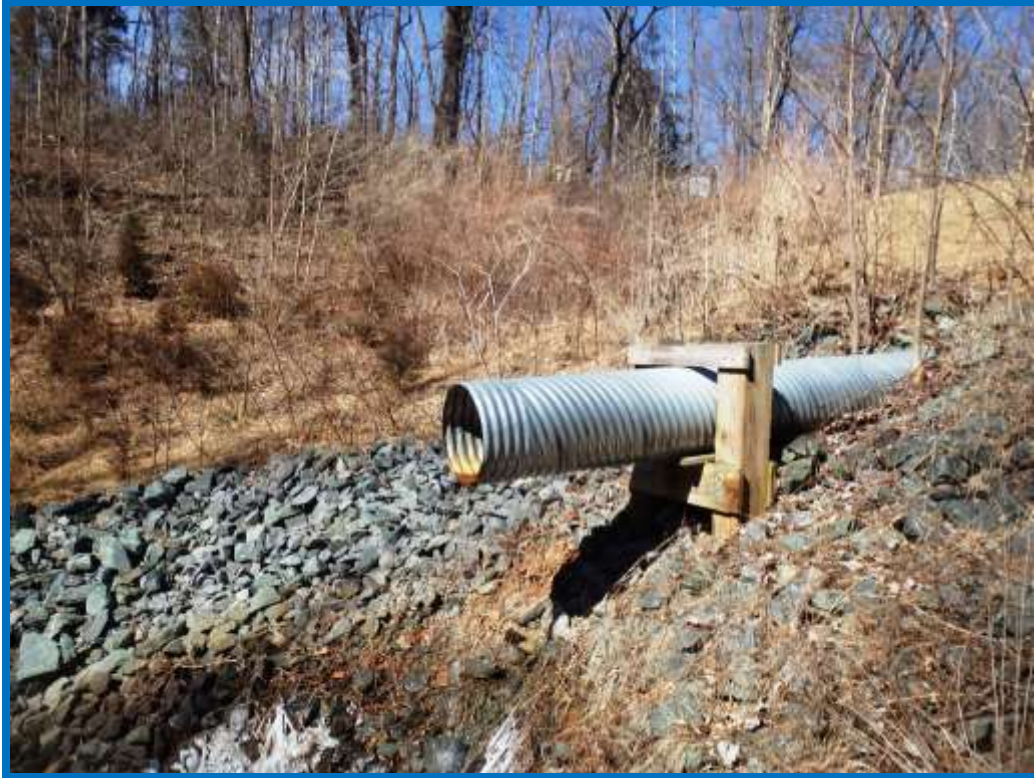
Figure 15 - Outfall Pipe and support

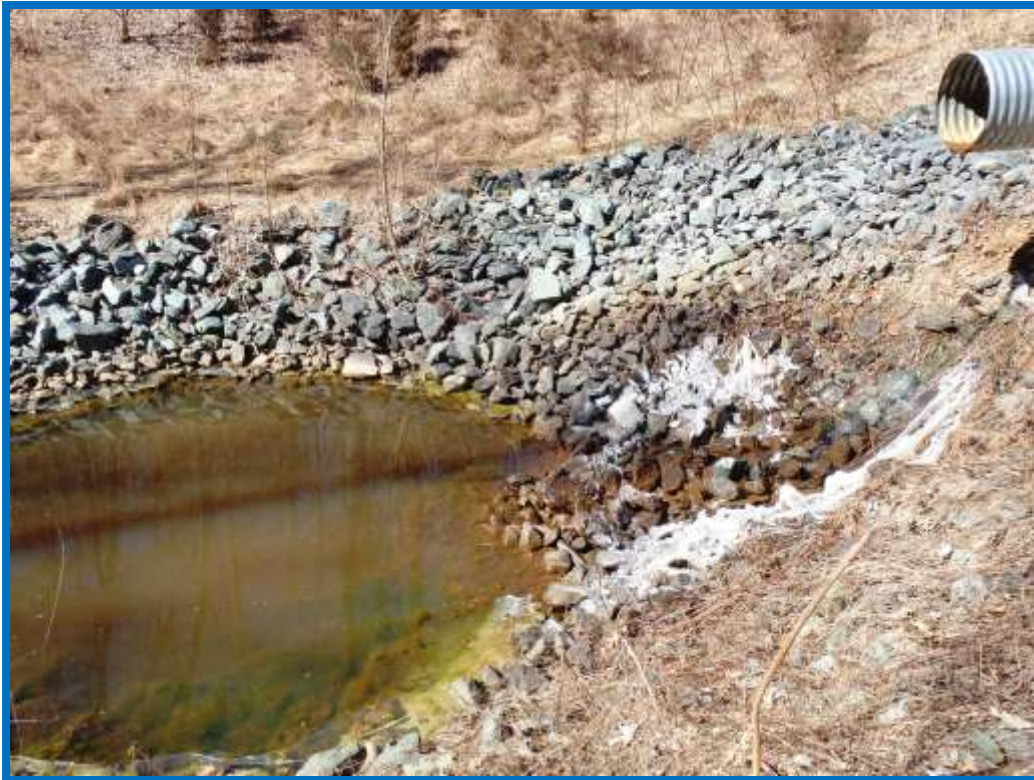
Primary spillway flows exit the outfall pipe into a plunge pool immediately downstream. The bottom invert of the outfall is approximately 10 feet above the plunge pool. The plunge pool has steep banks and is lined with rock rip rap. There appears to be positive drainage from the plunge pool, away from the dam.

Figure 16 - Plunge Pool

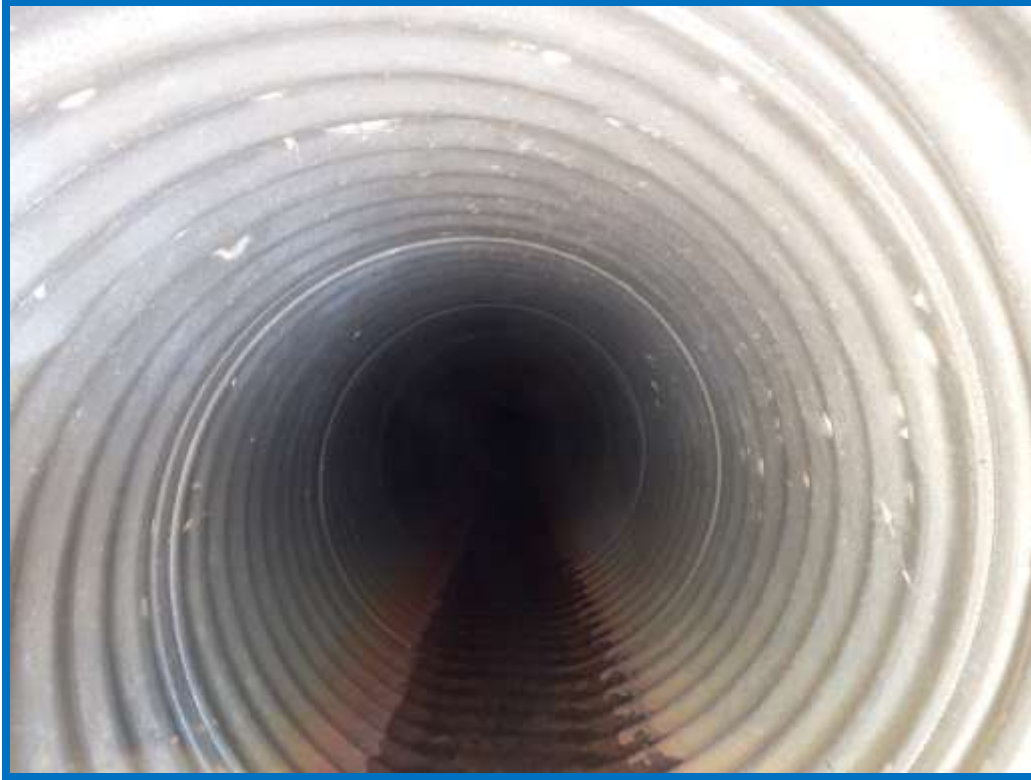
Figure 17 - Looking up into new section of CMP outfall

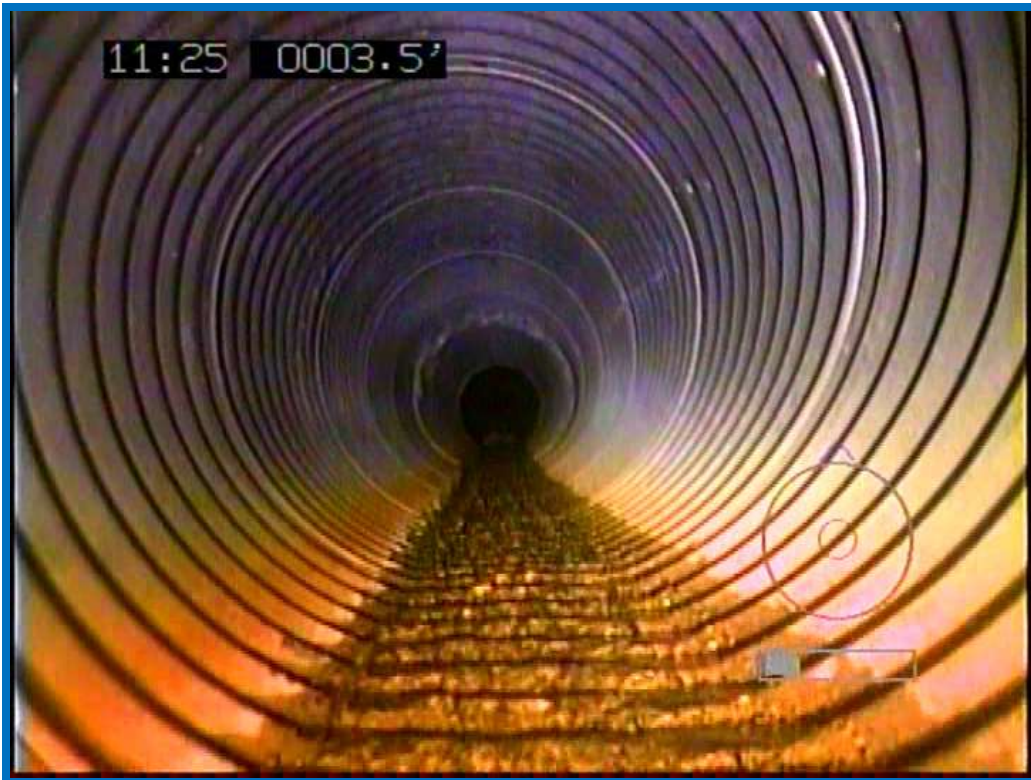
Figure 18 - Picture inside new section of CMP

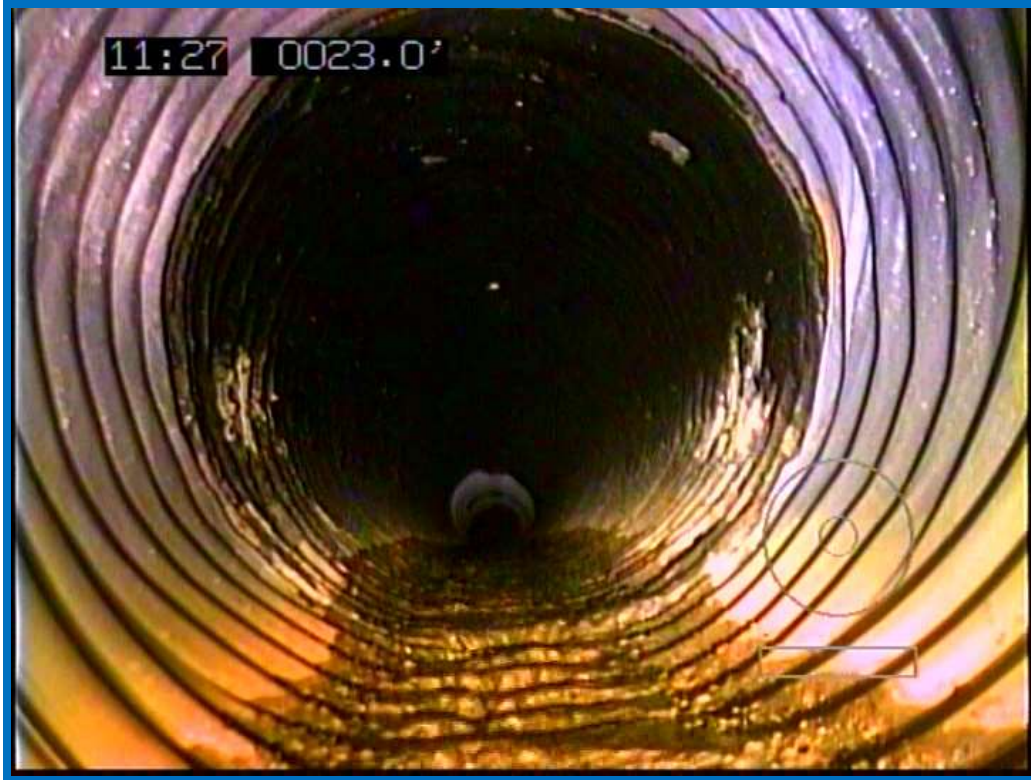
Figure 19 - Picture at Transition from new to old CMP

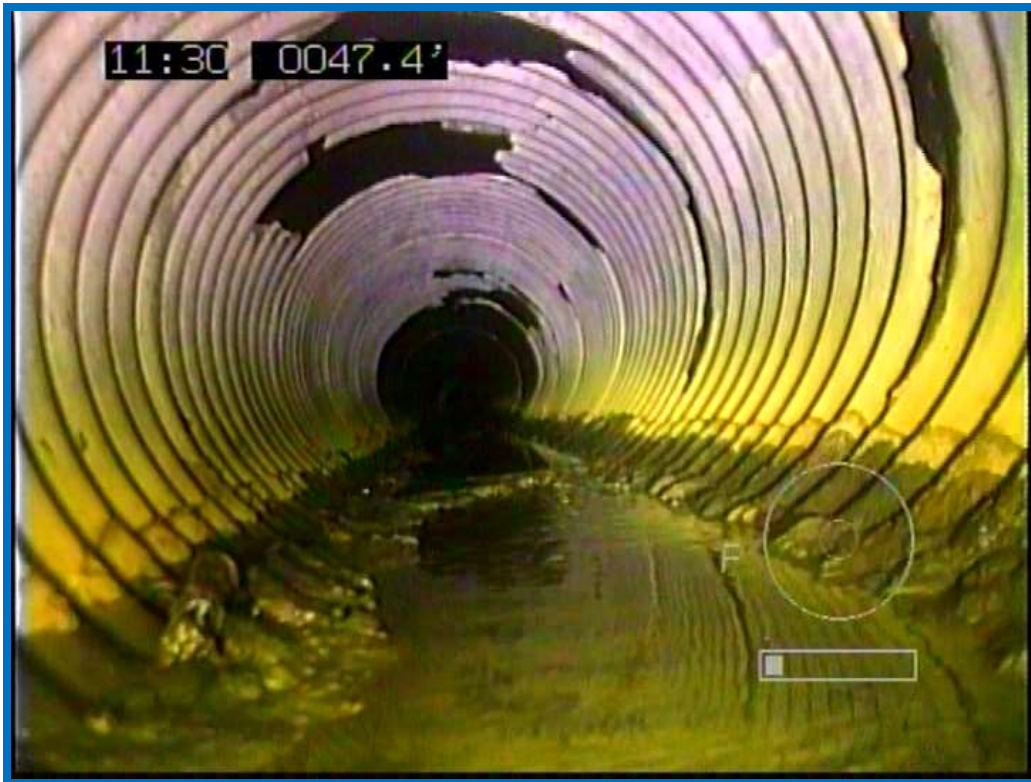
The remainder of the outfall consists of the original corrugated metal pipe. It is showing some deterioration throughout but no noticeable damage, failures, or leaks. Approximately 5% to 10% of the asphaltic coating remains on the pipe walls. On the last joint (Joint #7) the gasket is exposed and is hanging down from the top of the pipe. No leaks were noted in this area. The pipe is relatively straight throughout, however there are a few undulations and areas where sediment has accumulated. This is noticeable in the video by ponding water in the bottom of the pipe.

Figure 20 - Typical view of existing CMP, note patches of coating

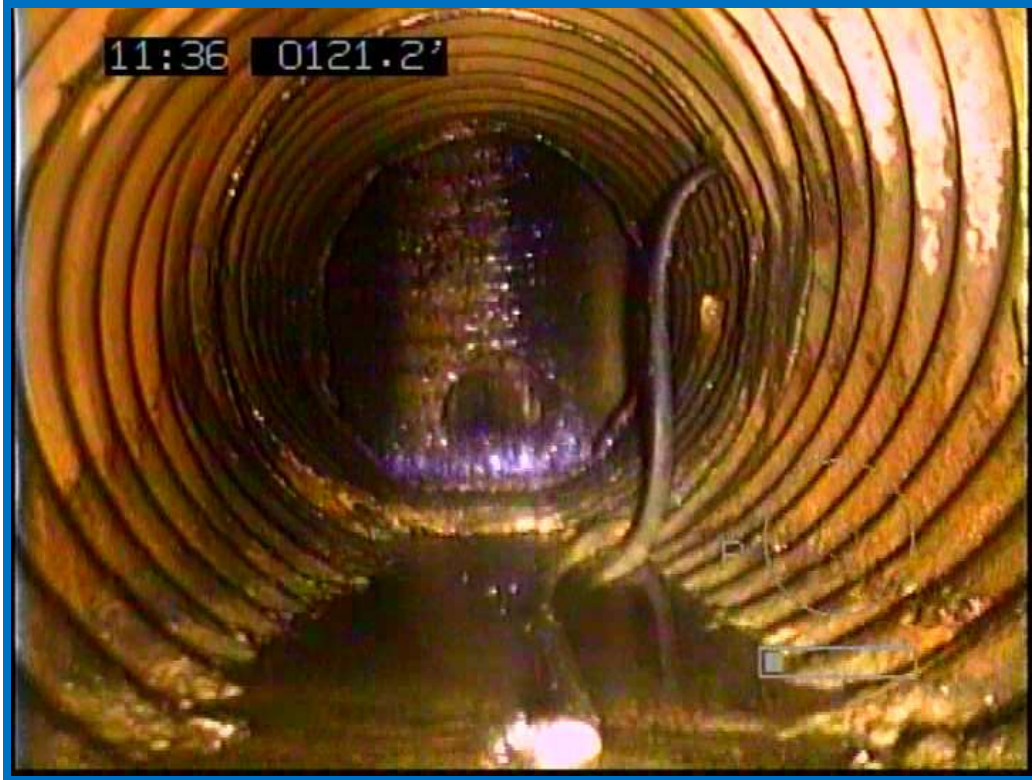
Figure 21 - Joint 7 as it transitions to riser

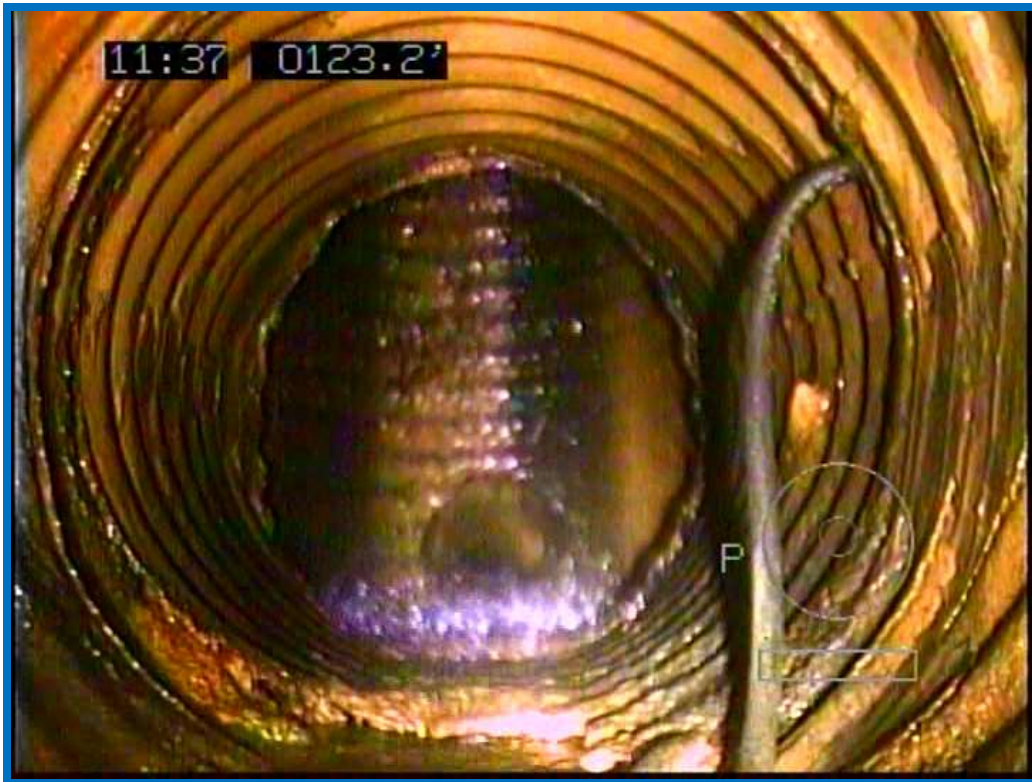
Figure 22 - Close-up of gasket sticking out of Joint 7

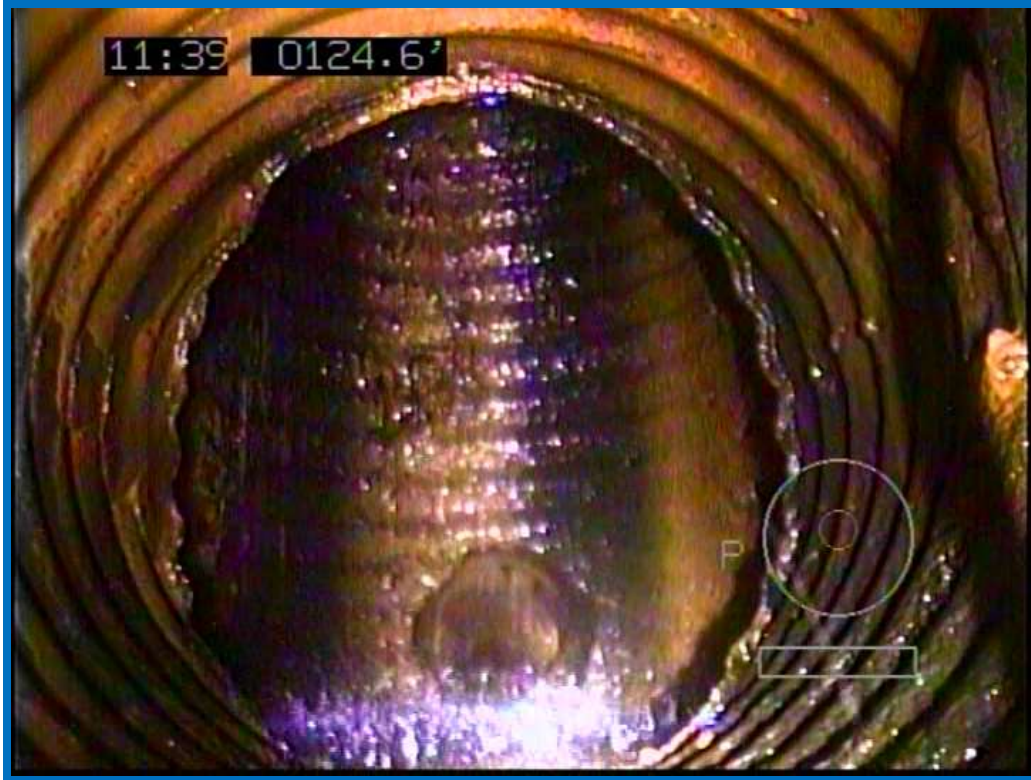
Figure 23 - Riser and Low Level Drain in background

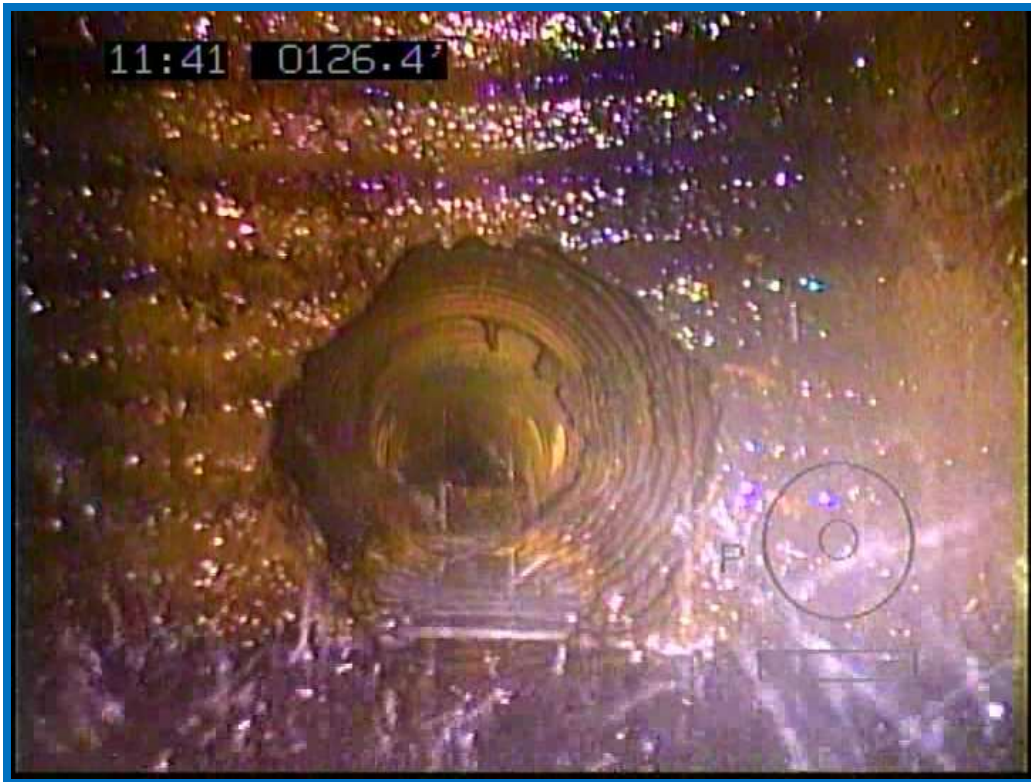
Figure 24 - Looking across riser into low level drain pipe
