# Peacock Hill Dam Primary Spillway Inspection Report

**March 4, 2014**

**Dam Name:** Peacock Hill Dam, VA  
Inventory # 00351

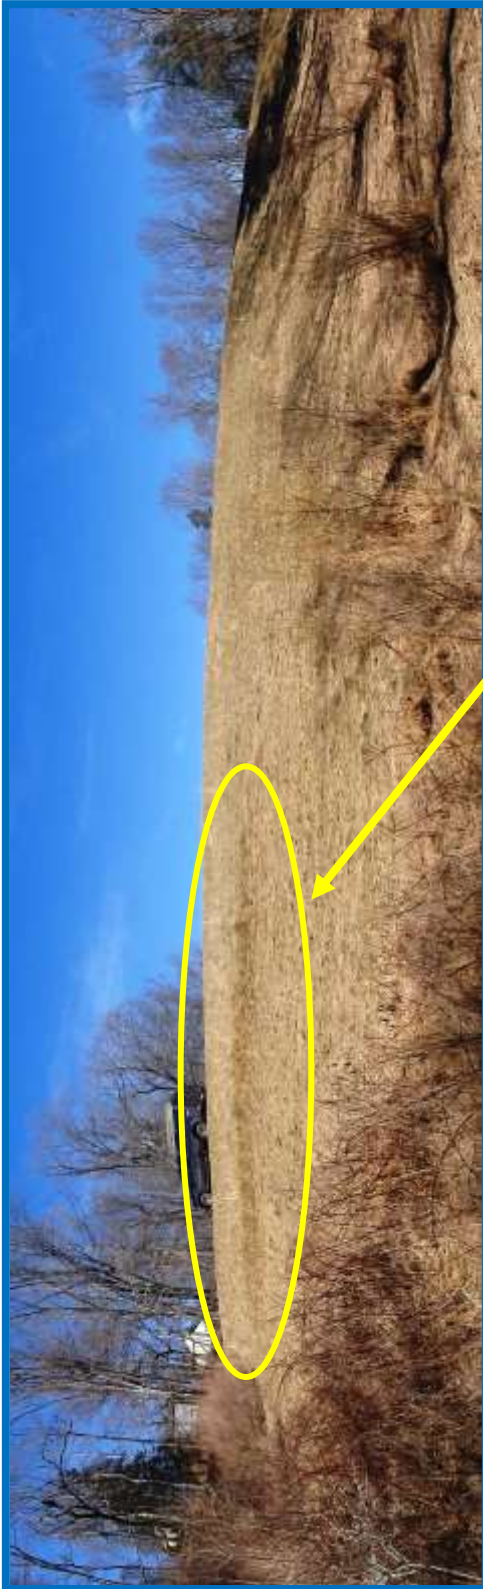
The upstream slope of the dam does not have any armoring against wind and wave erosion, but appears to be in good condition. The downstream slope has a line of differing vegetation approximately 1/3 of the way from the crest, which would indicate some wetness. The downstream also has a slight bulge towards the middle, but it is unclear if this is from a past slide or from original construction. The downstream slope appeared stable and not excessively wet at the time of inspection.

Wet Area about 1/3 of the way down the downstream slope.  
Also noted by change in vegetation in this area

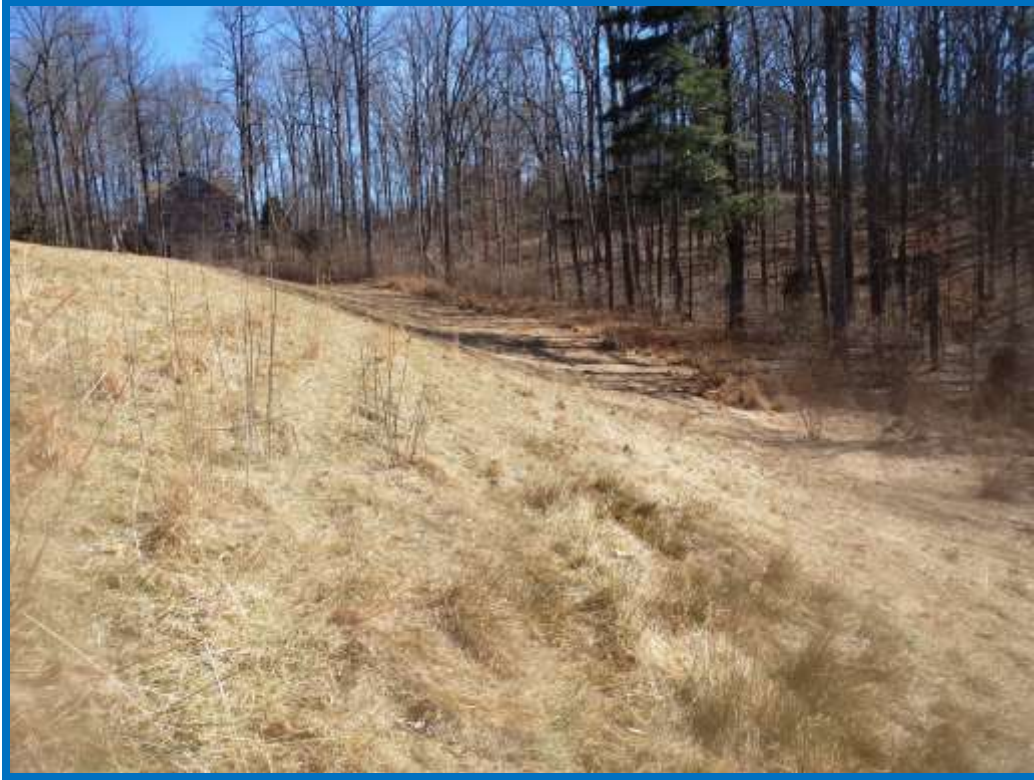
**Figure 25 – Middle of the dam looking towards the left abutment**

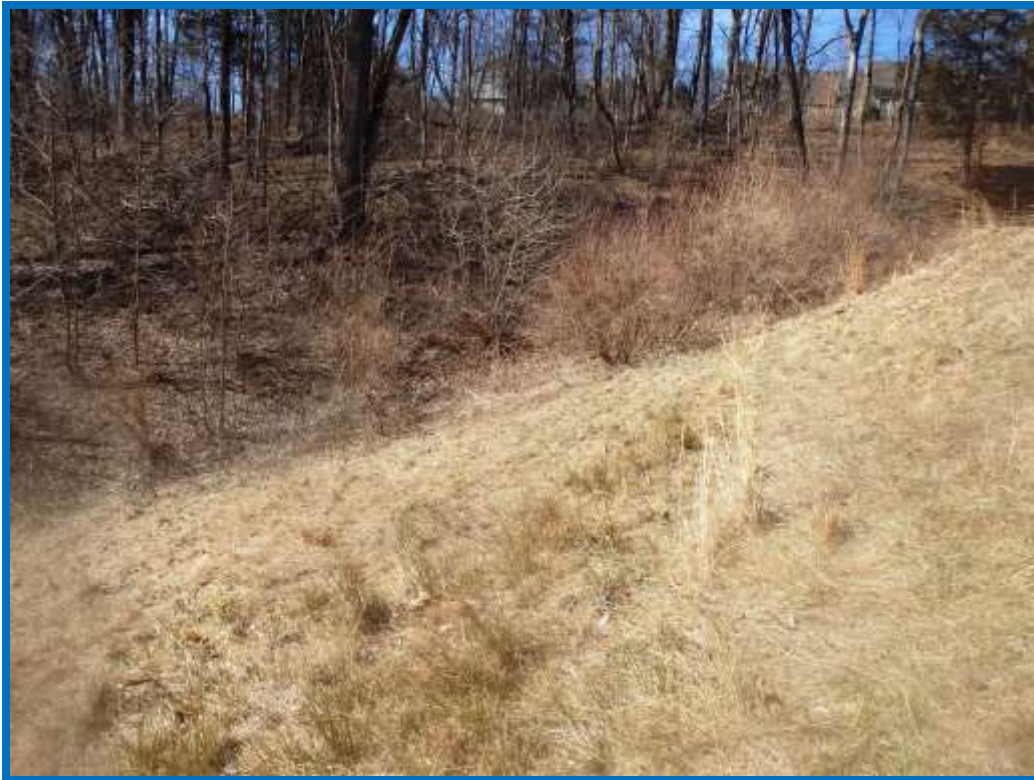
**Figure 26 - Middle of the dam looking towards the right abutment**

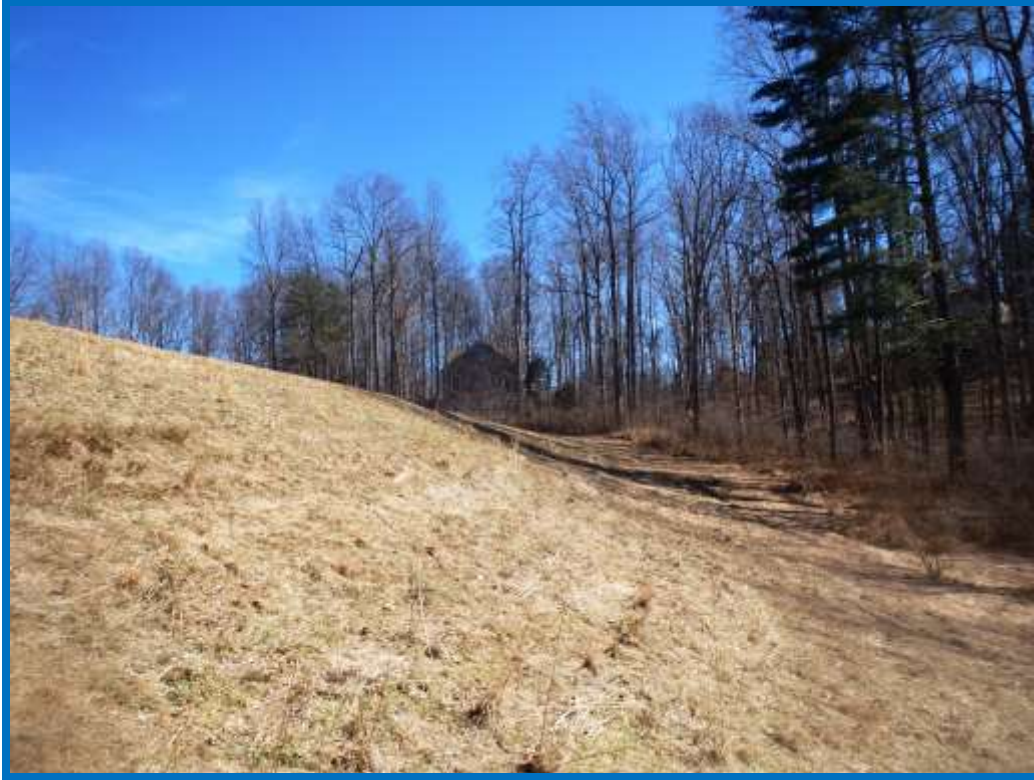
The auxiliary spillway is a 35-40 foot wide grass lined channel on the left (East) abutment of the dam. The control section of the auxiliary spillway is estimated to be 2 feet above the normal pool level and 3 feet below the crest of the embankment. The spillway was level with a good stand of grass, and no signs of erosion were noted in this location.

**Figure 27 - Auxiliary Spillway and channel**

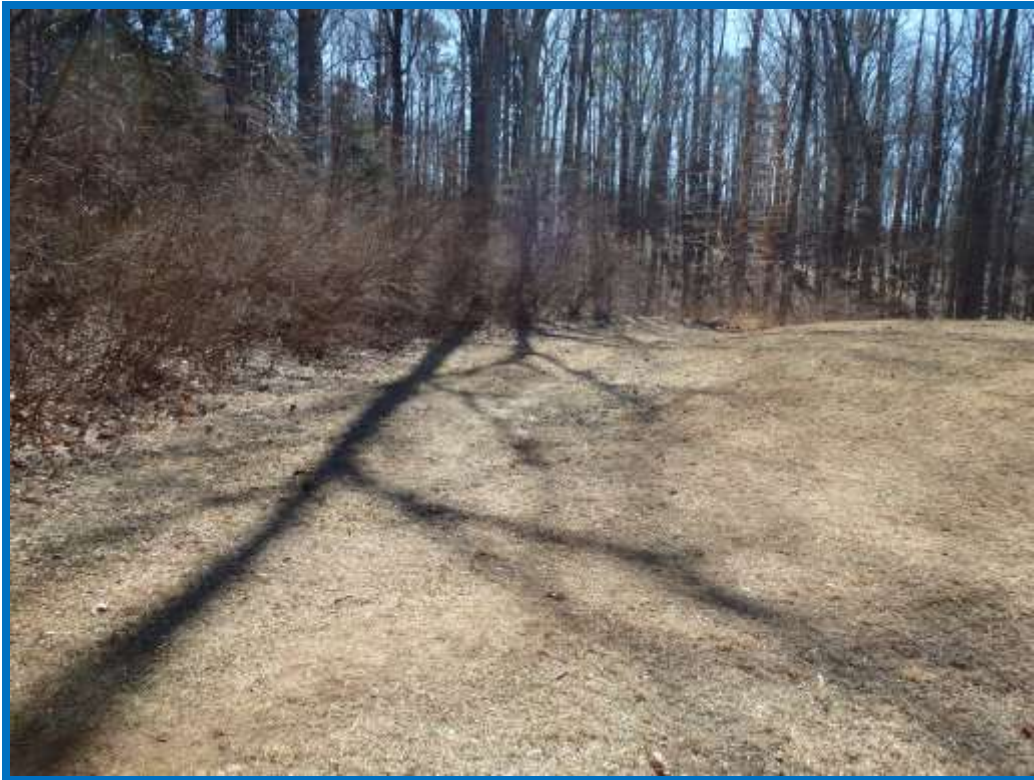
**Figure 28 - near lake shore looking downstream at auxiliary spillway**

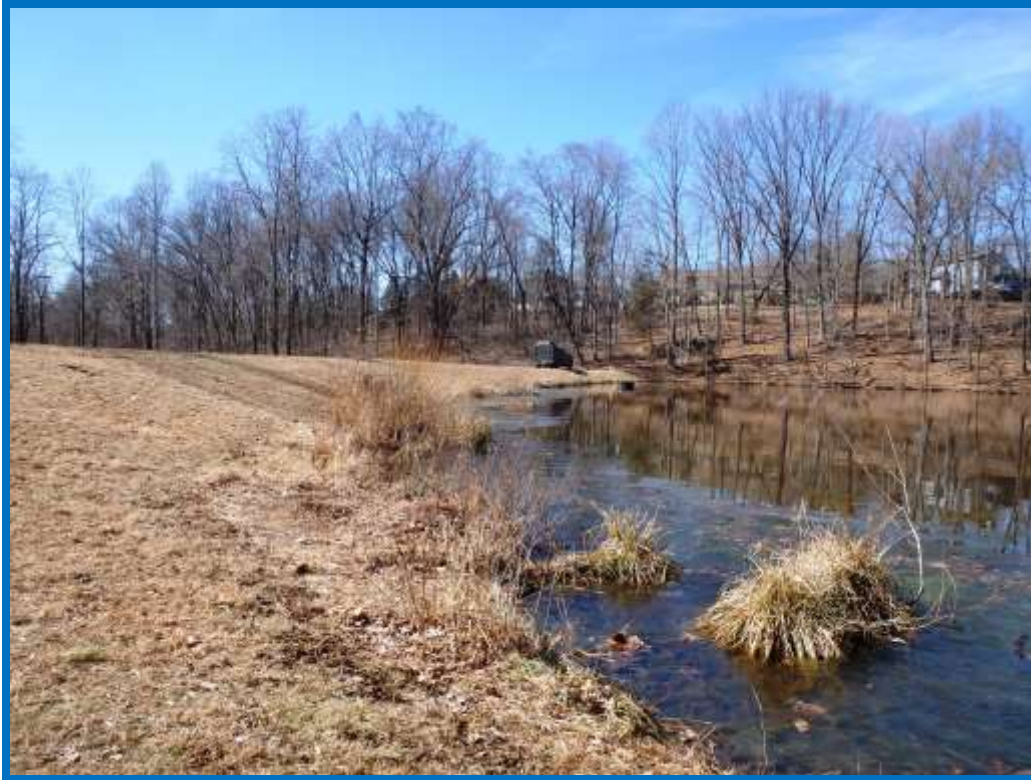
**Figure 29 - Looking across upstream embankment towards right abutment**

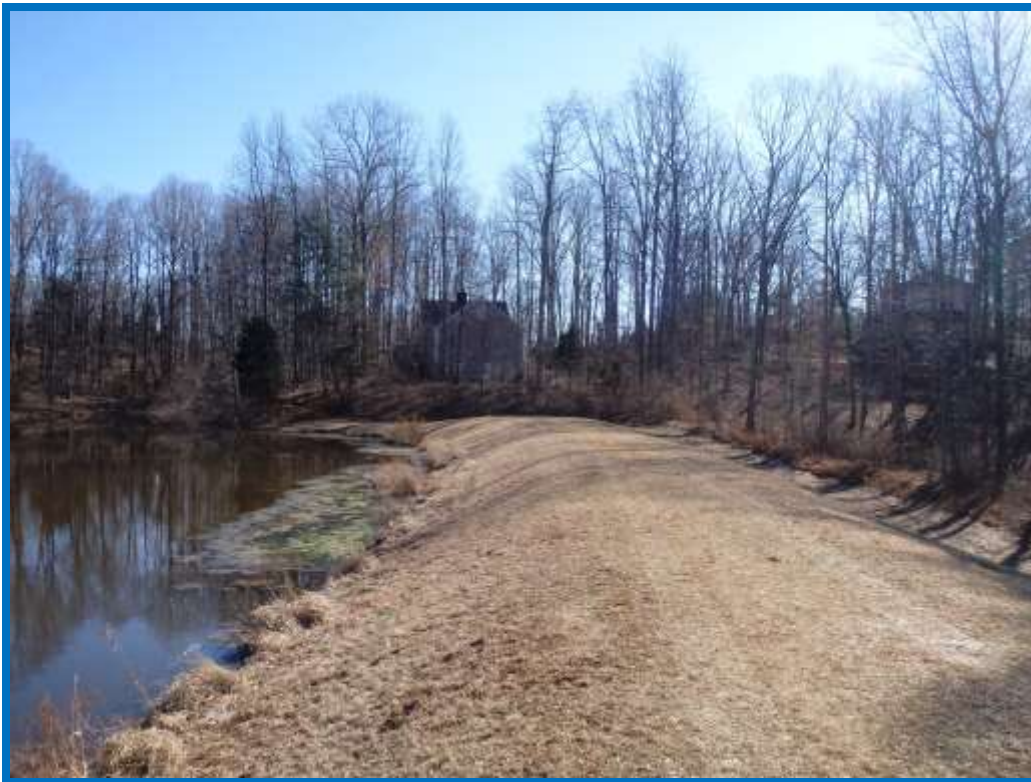
**Figure 30 - Looking across the crest of the dam towards left abutment and auxiliary spillway**
